The light indicating the toaster is on will not work. This guide is will lead you to steps that will repair the light.

Use this guide to repair the clear indicator light. This guide will help you through replacing the light bulb.

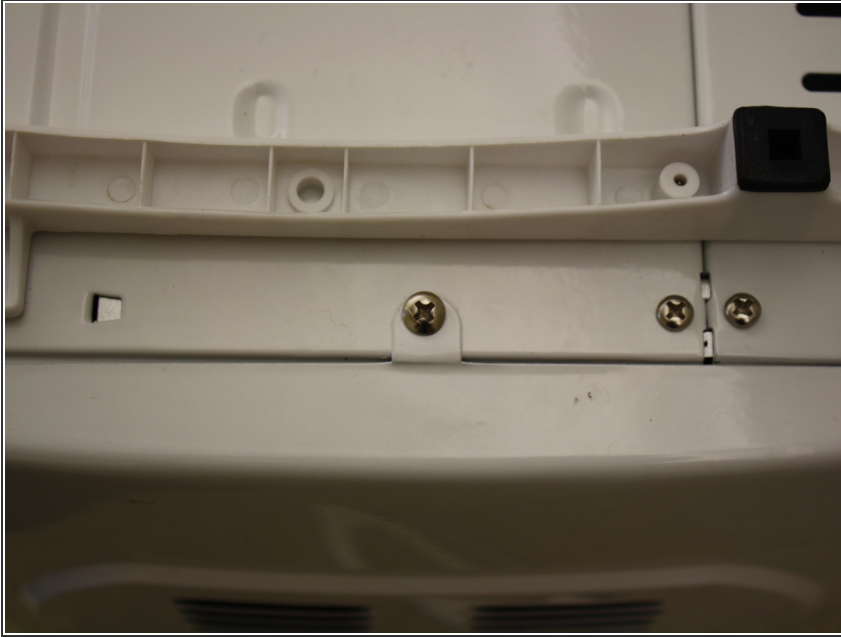
Step 1 — Indicator Light

- ⚠ Make sure toaster is unplugged.
- Turn toaster upside down so screws on bottom side are facing toward the ceiling and the door is facing towards you.

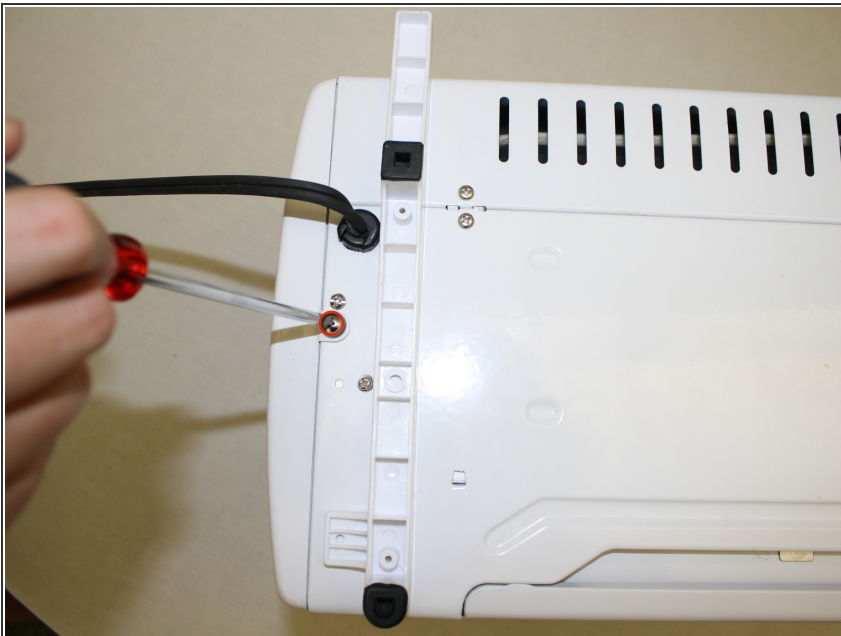
Step 2

- On the left hand side, unscrew the middle screw.

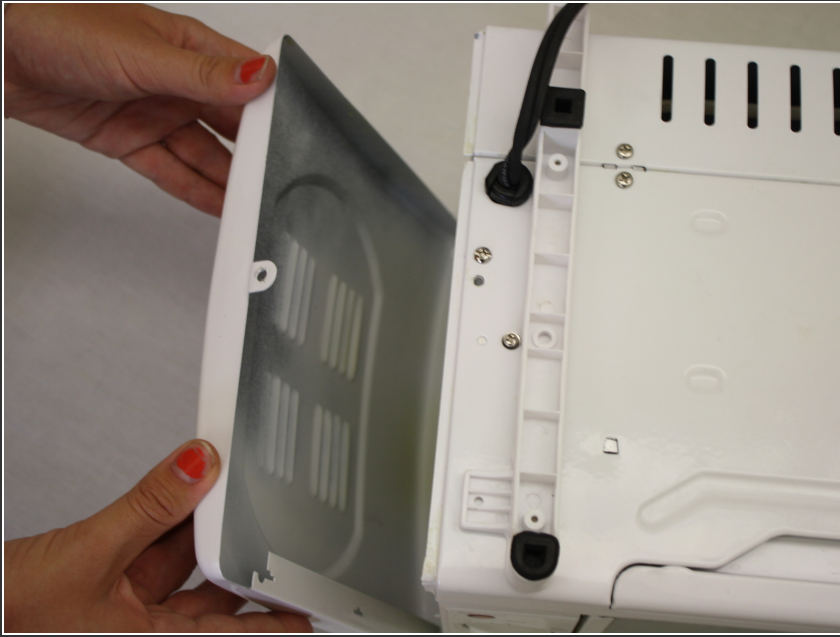
Step 3

- Remove the panel on the left hand side. The indicator light is located in the red tube that has wires covered by black tubing coming out.

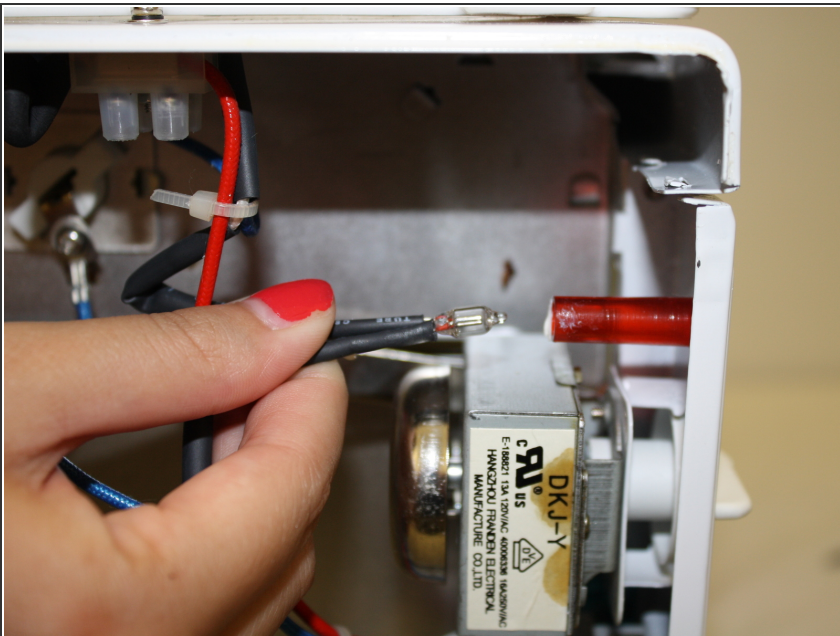
Step 4

- Pull the black wires to remove the indicator light from the red tube.

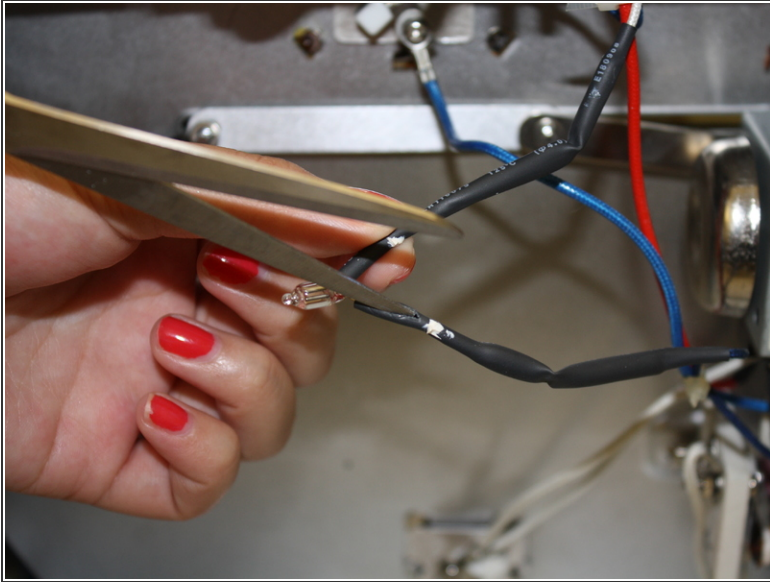
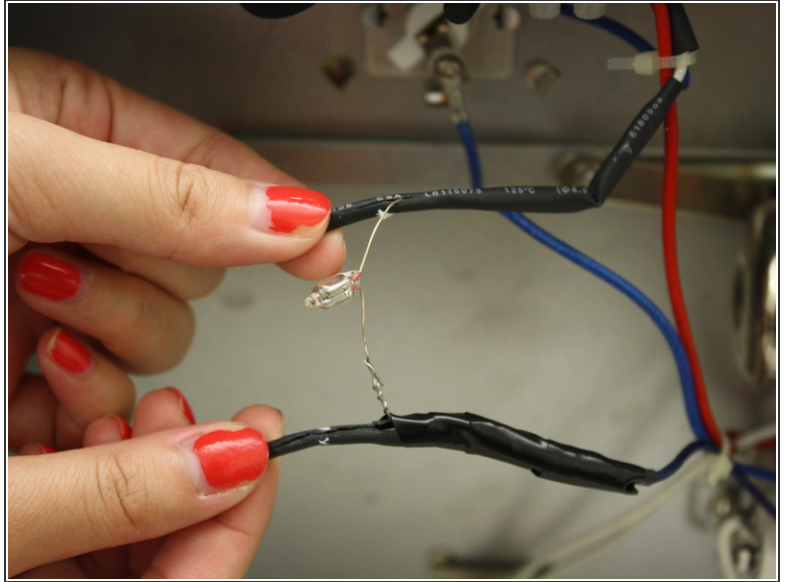
Step 5

- Use scissors to cut open cord sheathing and peel back.

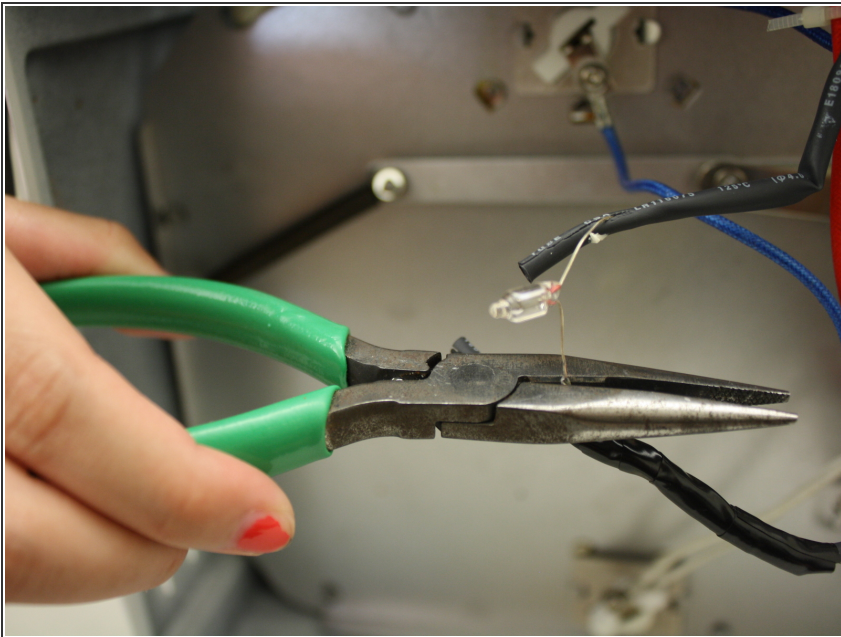
Step 6

- Use the wire-cutters to remove the light bulb.

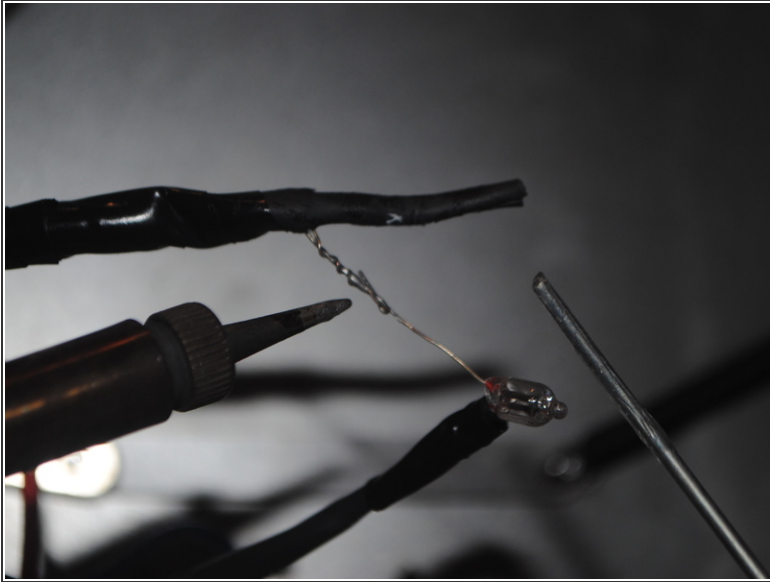
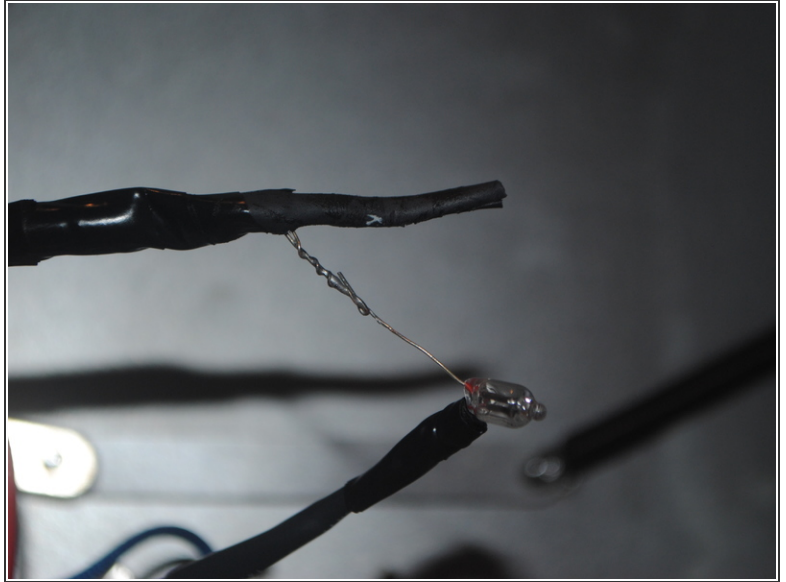
Step 7

- Solder the replacement light bulb back onto its original position.

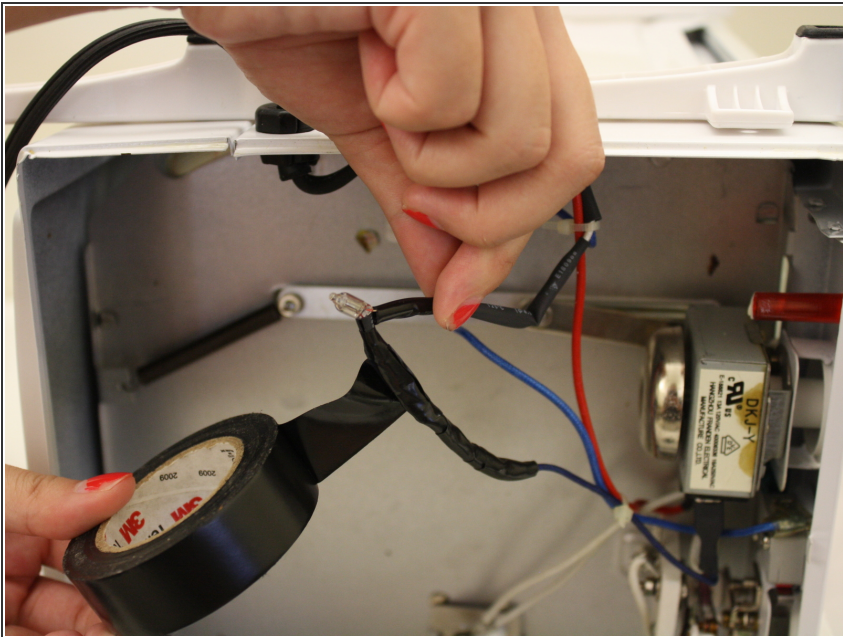
Step 8

- Use electrical tape to reseal the sheathing.

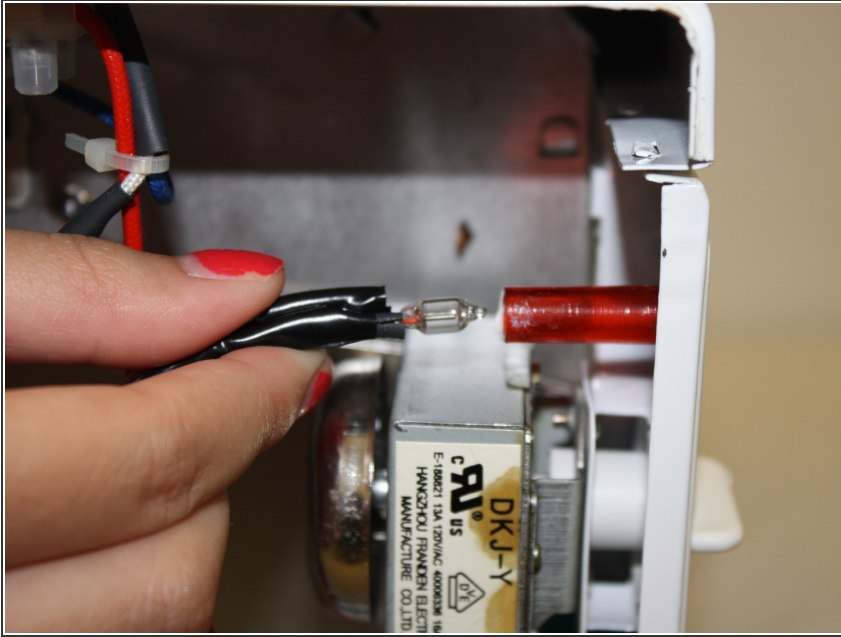
Step 9

- Reinsert the indicator light back into the red tube.

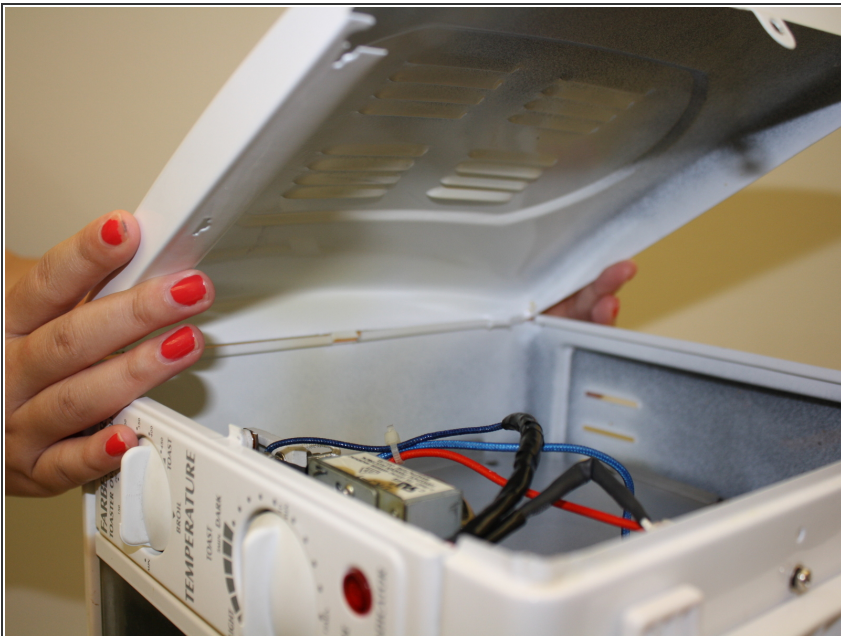
Step 10

- Turn toaster upside down so screws on bottom side are facing toward the ceiling and the door is facing towards you.

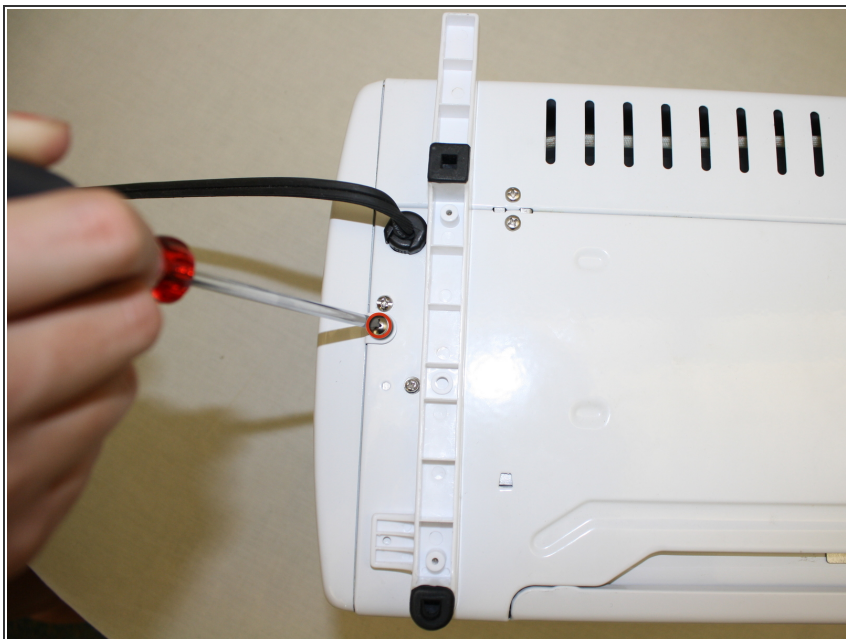
Step 11

- On the left hand side, screw the middle screw back in.
